Pavement Condition Report

Final Report

Medicine Lodge Airport (K51)

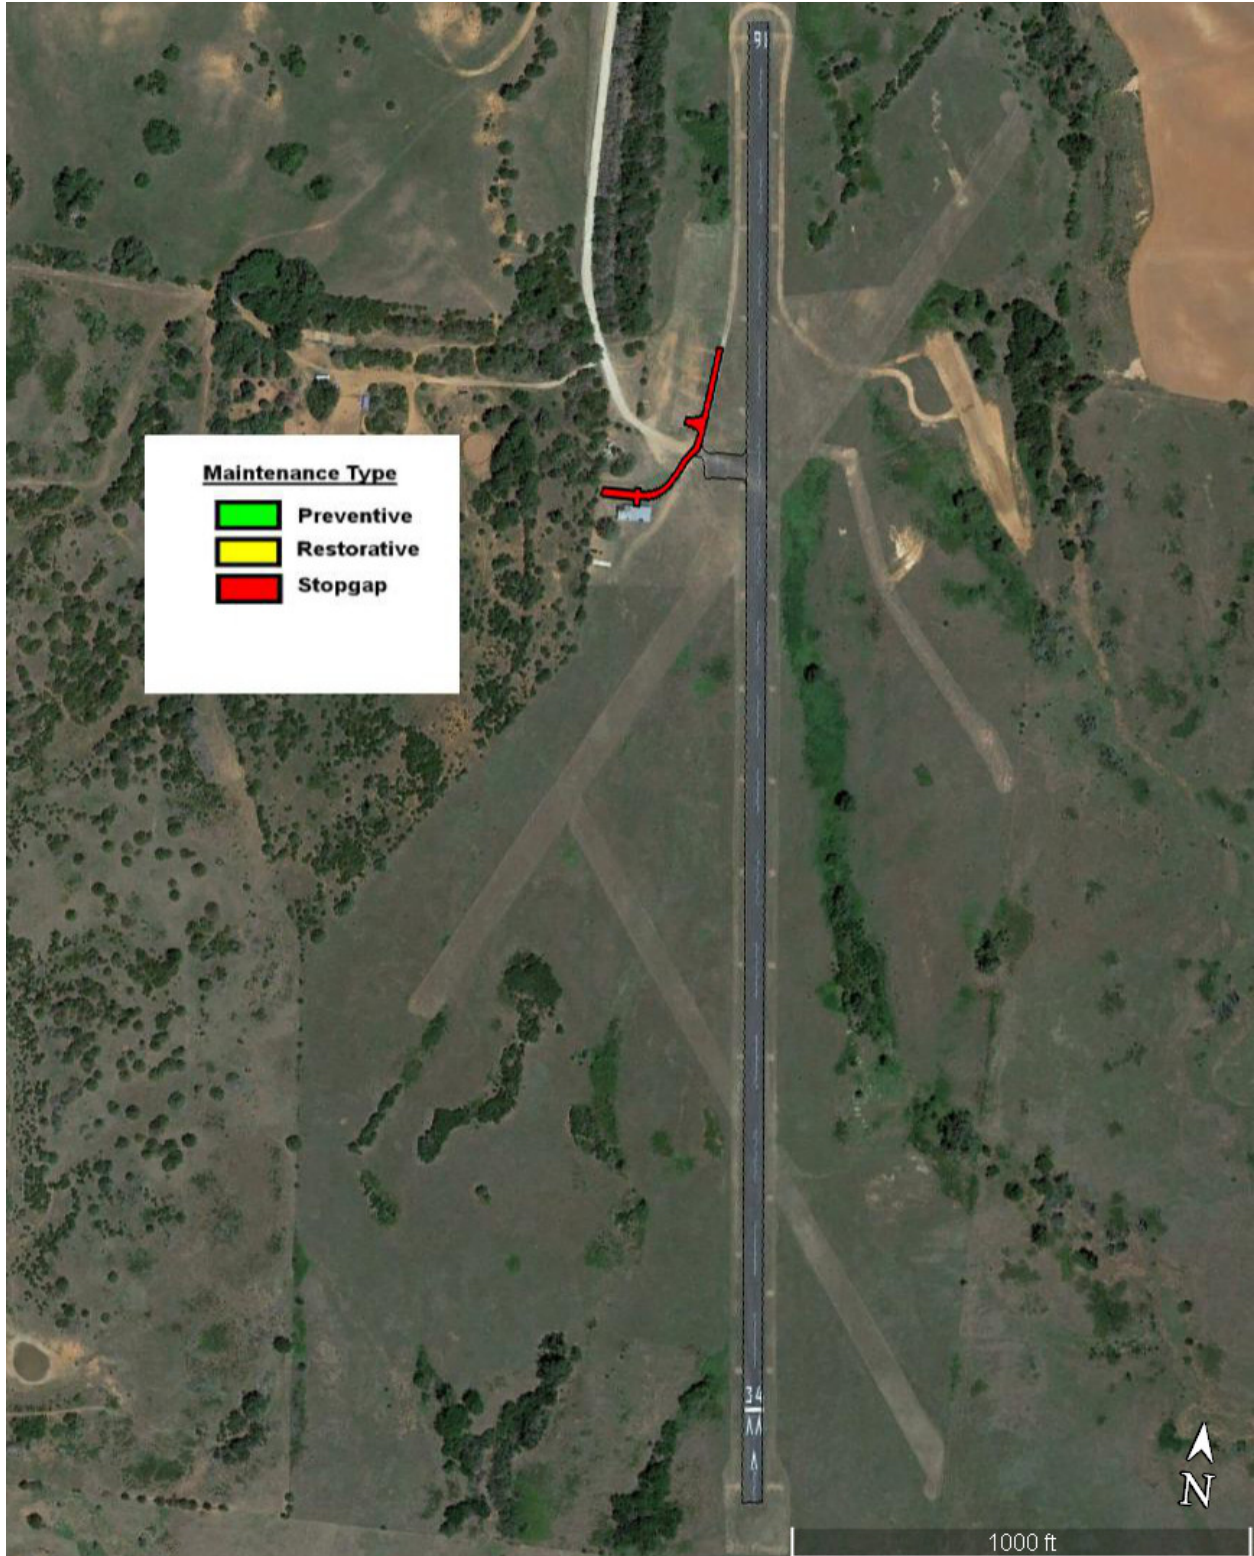
Figure 8. Maintenance type

Branch	Section	Work Type	Quantity	Unit	Cost
TLA	001	Crack Sealing - AC	280	Ft	\$302
TLA	001	Patching - AC Deep	251	SqFt	\$3,159
TLA	001	Surface Seal	7,020	SqFt	\$4,212

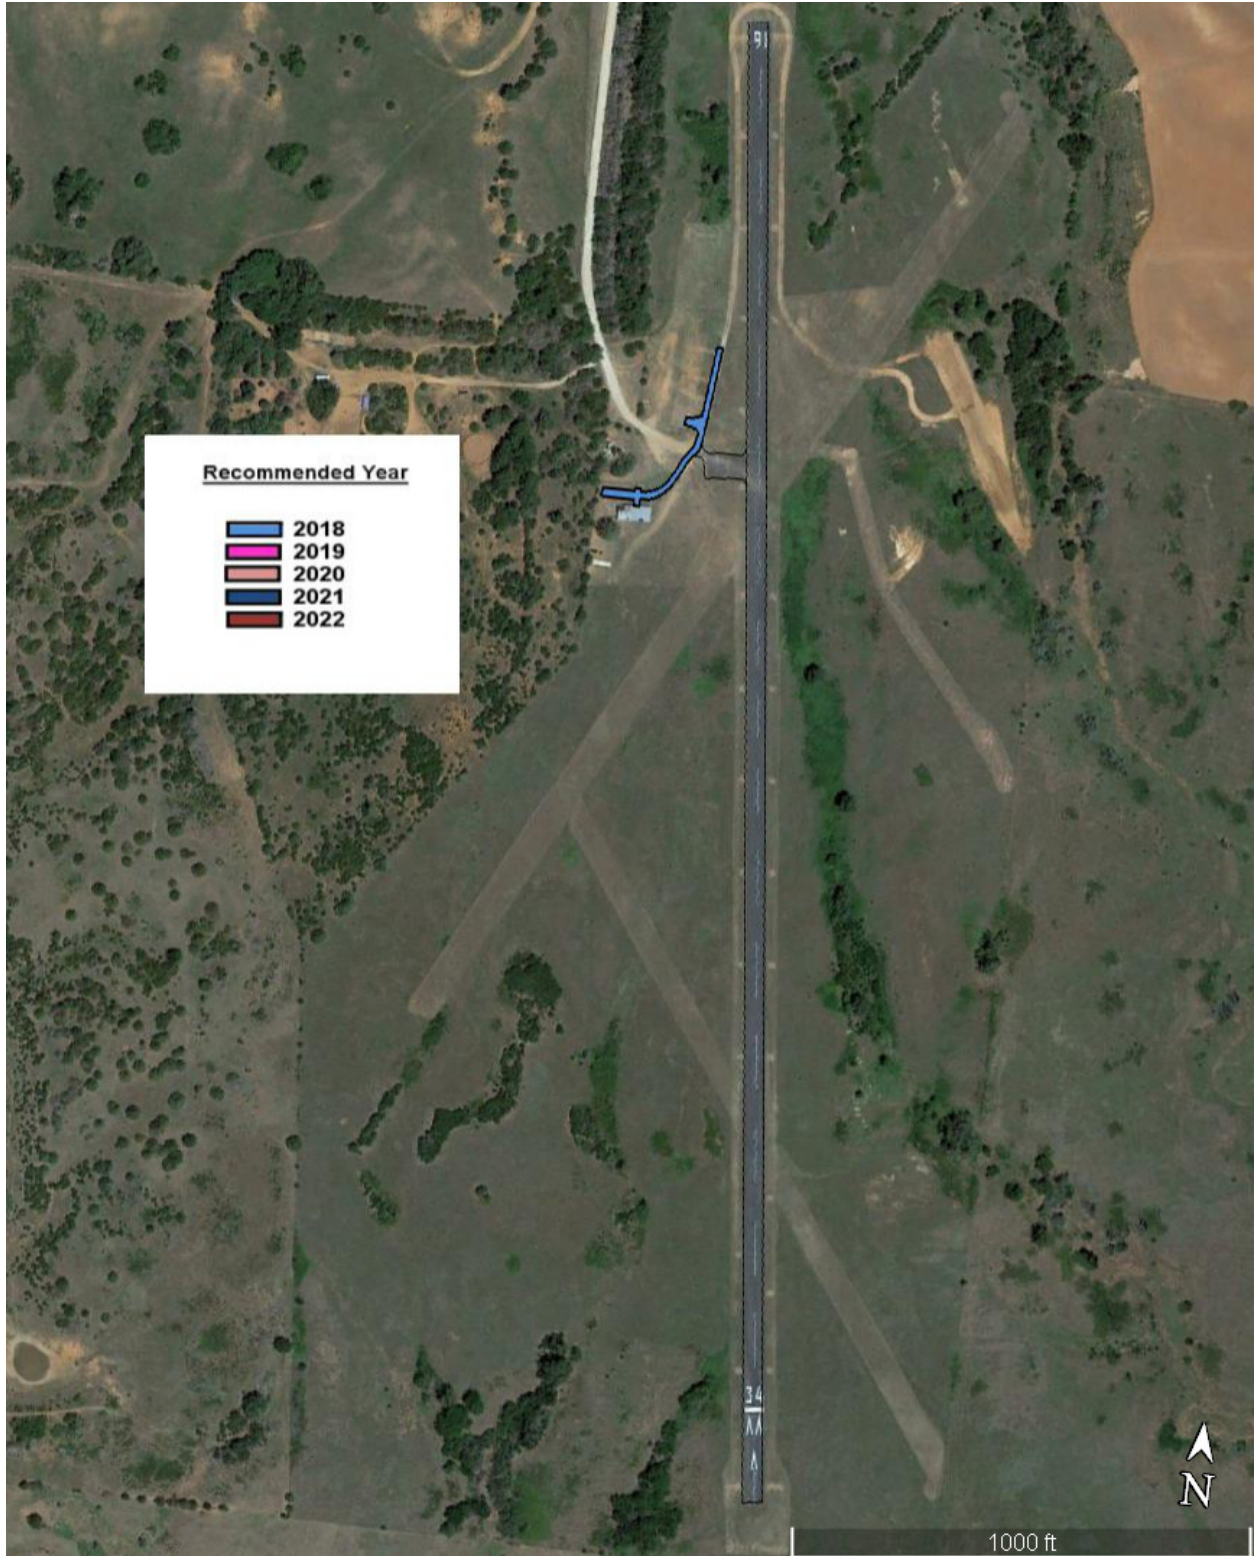
Figure 9. Major M&R

Branch ID	Section ID	Year	Predicted PCI Before Rehab	Estimated Cost
TLA	001	2018	31	\$48,826
5-year Airport Total				\$48,826

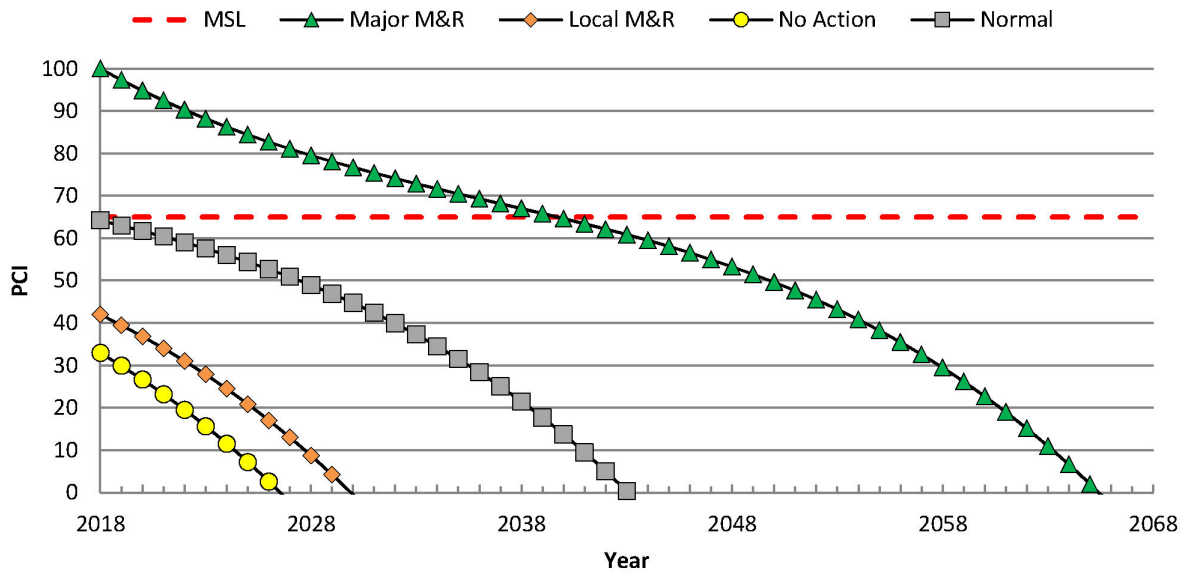
Section: **K51::TLA::001**

Description: Taxilane A

M&R	Action	Year / Quantity	Cost (\$)	Ending PCI
Major	Major M&R	2018	48,826	100
Local	All Local	2018	7,673	42
1	Surface Seal	7020 SqFt	4,212	-
2	Patching - AC Deep	251 SqFt	3,159	-
3	Crack Sealing - AC	280 Ft	302	-
4	-	-	-	-
5	-	-	-	-
6	-	-	-	-
7	-	-	-	-
