Pavement Condition Report

Final Report

Medicine Lodge Airport (K51)

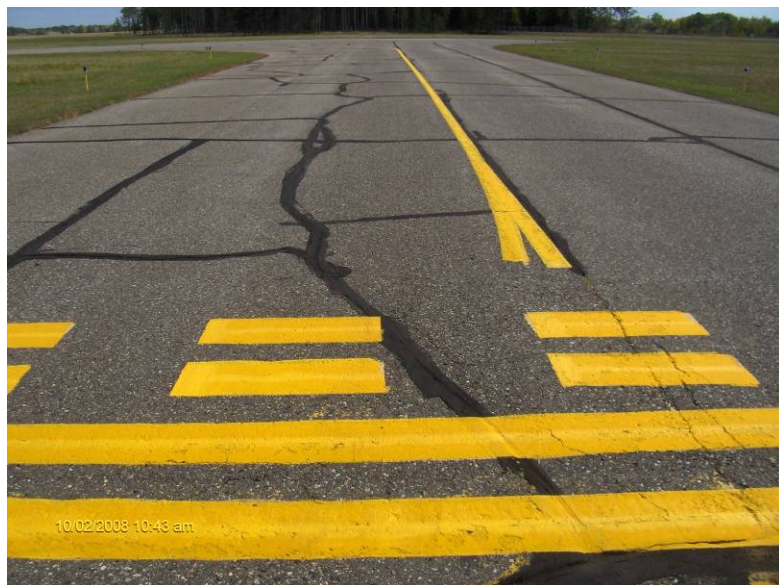
Example of Longitudinal and Transverse Cracking (L&T cracking)

Longitudinal and transverse cracks are caused by pavement aging, by construction, and by subsurface movement. Aging occurs as pavement loses some of its components to the atmosphere and becomes more brittle. Consistent application of pavement sealcoats can help to prevent the occurrence of age related cracks. Cracks will also develop along poorly constructed paving lane joints. Ensuring that joints are made when both sides are still hot, and near the same temperature, is one of the best ways to mitigate this potential problem. Seasonal movement caused by changes in moisture content or temperature differences can also cause pavement cracks. Asphalt pavement placed over a PCC pavement or cement stabilized base course may evidence reflective cracking from the underlying material. Longitudinal and transverse cracks are not caused by wheel loads, although traffic may worsen their condition.

Low severity longitudinal and transverse cracks are less than ¼ inch wide, or if sealed with suitable filler material in satisfactory condition can be any width, less than 3 inches, if they are not spalled. Maintenance usually is not indicated for low-severity cracking. Moderately spalled cracks and cracks wider than ¼ inch which are not satisfactorily sealed are at medium severity. Medium-severity cracks should be sealed with a high-quality crack filling material. Severely spalled cracks and cracks wider than 3 inches are at high severity. High-severity L&T cracks normally require patching.

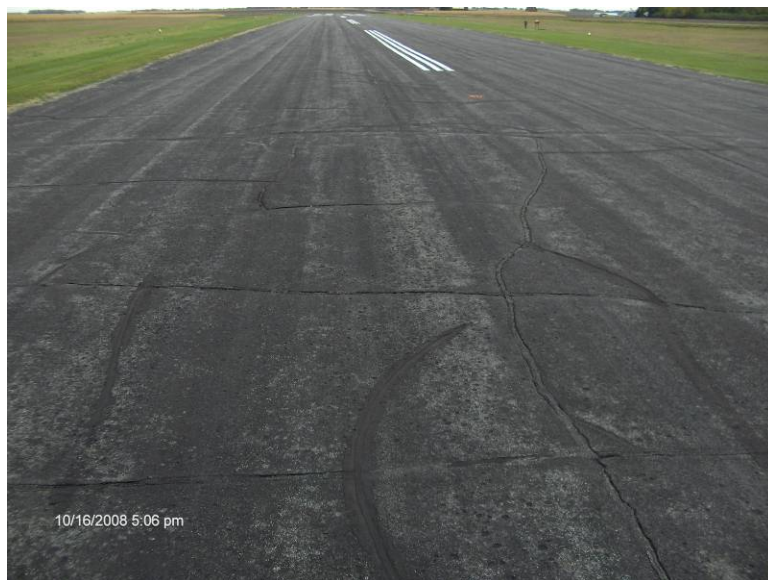
Example of Block Cracking

Block cracking is longitudinal and transverse cracking that has established a pattern of blocks ranging in size from 1ft x 1ft to 10ft x 10ft. This distress typically happens in older asphalt pavements and is an indication that the bituminous binder has lost most of its flexibility. The severity determination is basically determined by the crack width criteria defined for longitudinal and transverse cracking. Crack sealing typically is used to repair block cracking; however, the amount of required sealant can be extensive due to the high density of cracks.

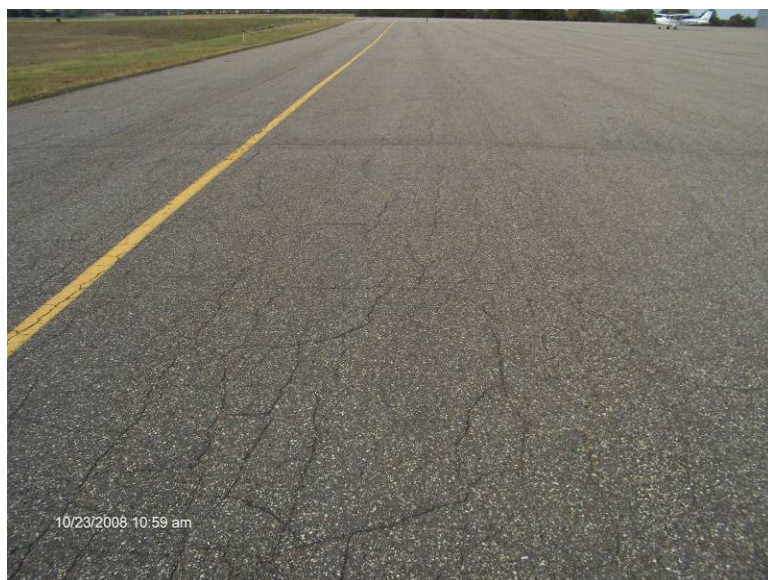
Example of Alligator Cracking

Alligator (or fatigue) cracks are a series of interconnected load-related cracks caused by fatigue of the asphalt surface. Alligator cracking is a significant structural distress and develops only in places subject to traffic loads. These cracks typically initiate at the bottom of the asphalt layer (where tensile strains

are highest) and propagate upward - so once a fatigue crack is visible, significant damage has already occurred.

At low severity, alligator cracks are evidenced by a series of parallel hairline cracks (usually in a wheel path). Further traffic and deterioration leads to the interconnection of these cracks. Medium severity alligator cracking is a well-defined pattern of interconnected cracks, some spalling may be present. High severity alligator cracks have lost aggregate interlock between adjacent pieces, the cracks may be severely spalled with FOD potential, and most likely the pieces will move freely under traffic. Alligator cracking is a structural failure and cannot be repaired with sealant, the proper repair is full-depth patching.

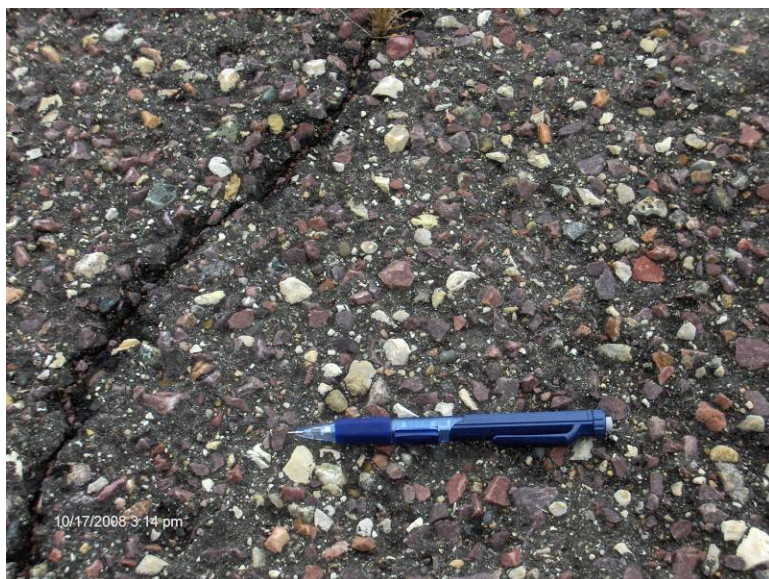
Example of Raveling/Weathering

Raveling and weathering are the wearing away of the pavement surface. Raveling is the condition where the mid- to large size aggregates are becoming dislodged; weathering is when the fine aggregate wears away exposing the edges of the larger aggregate. These distresses are usually evident over large areas and may occur together (pictured above) or separately. Raveling and weathering may indicate that the asphalt binder has hardened significantly.

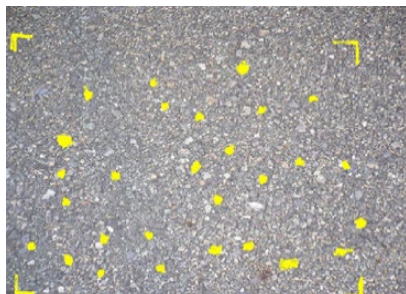
Raveling – At low severity, the number of missing coarse aggregates (> 3/8 inch) is between 5-20 missing/yd², medium severity (pictured below where the missing coarse aggregates have been dotted with yellow paint) is 21-40 missing/yd², and high severity is > 40 missing/yd².

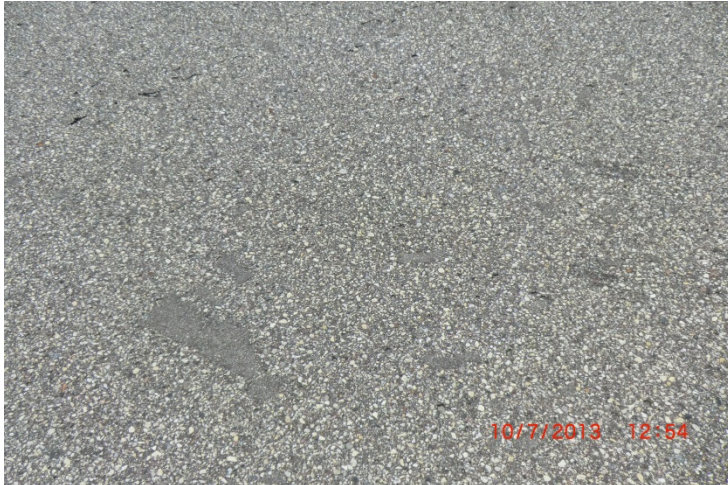
Low severity

Weathering – At low severity, the coarse aggregate is slightly exposed due to the wearing away of the fine aggregate. At medium severity, the coarse aggregate is exposed up to $\frac{1}{4}$ the width of the longest side. At high severity, the coarse is exposed greater than $\frac{1}{4}$ the width of the longest side.

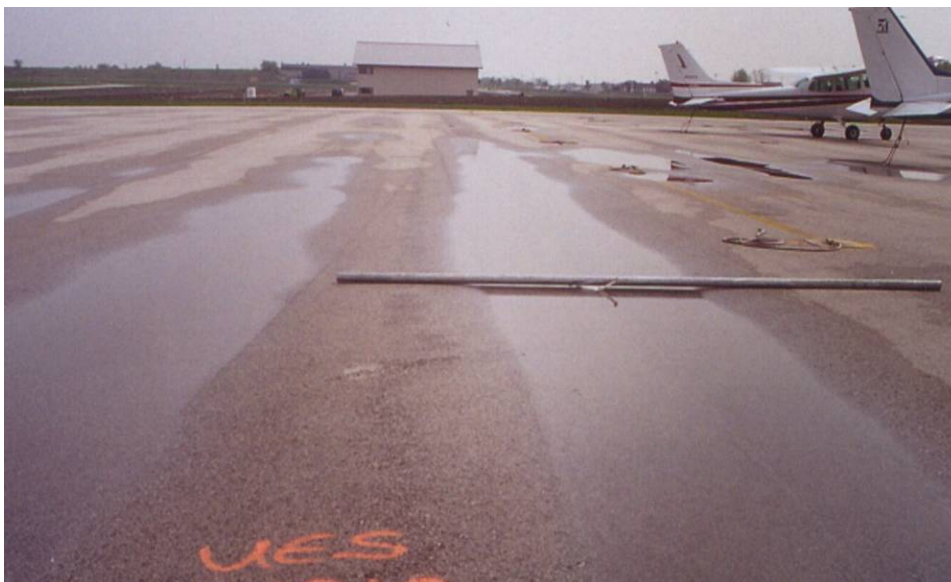
Example of Rutting

Ruts are localized, load related, areas of pavement having elevations lower than the surrounding sections. Rutting is due to base and subgrade consolidation, caused by excessive wheel loads or poor compaction. Ruts indicate structural failure, and can cause hydroplaning. At low severity, ruts have an

average depth of ¼ to ½ inches. At medium severity, ruts have an average depth of ½ to 1 inch. High severity, ruts have an average depth greater than 1 inch. Full-depth patching is the appropriate repair for ruts.

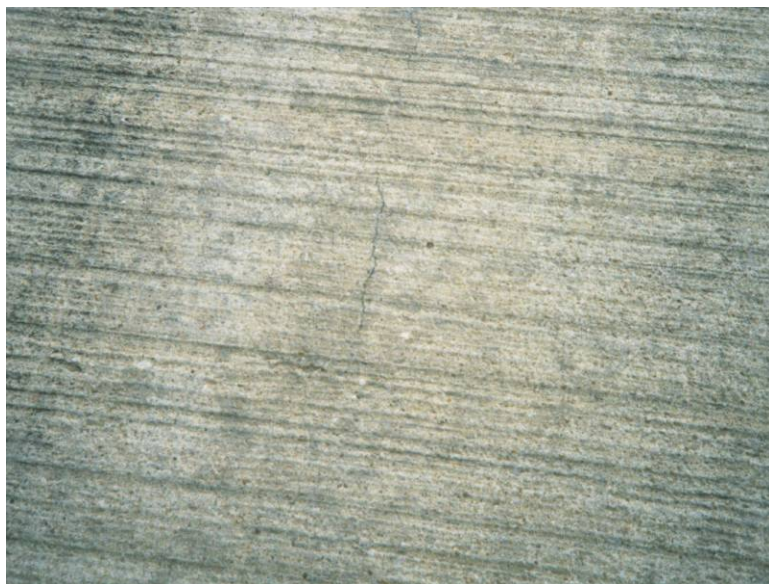
Example of Shrinkage Cracking

Shrinkage cracks are small, nonworking (no spalling along edge) cracks that are visible at the surface but do not penetrate through the full depth of concrete. Shrinkage cracks most commonly occur shortly after construction due to concrete shrinkage during the curing process. Shrinkage cracks are usually so small that they are not visible until staining or material loss at crack edges begins to take place. Shrinkage cracks do not represent a structural weakness, and no corrective action is prescribed.

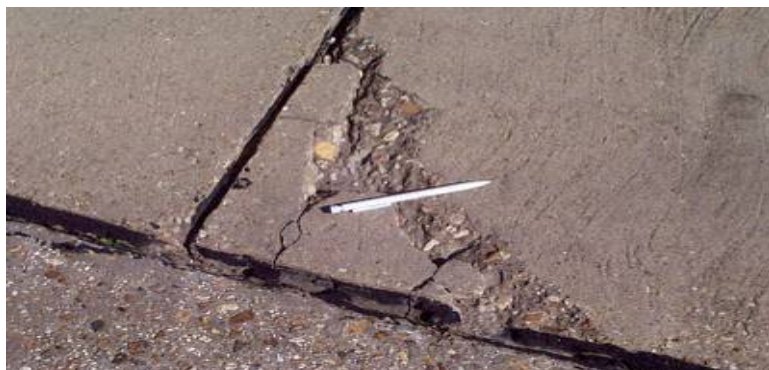
Example of Joint and Corner Spalling

Spalls at slab joints and corners are caused by excessive internal stress in the pavement. Spalls occur when these stresses exceed the shear strength of the concrete. Spalling usually results from thermal expansion during warm or hot weather. As slabs expand, they push against one another at joints. If the joints are filled with incompressibles, such as sand, or if adjacent slabs offset slightly, stresses can become severe, causing spalls. Spalling can be reduced significantly by conscientious maintenance of joint sealant.

Spall repair requires patching. The extent and severity of spalling on a pavement surface suggests appropriate action. For example, at low severity, spalled concrete remains securely in place in the slab. A low-severity spall should be monitored closely for further deterioration and should be patched when

spalled particles become loose in place, or at the next scheduled patching activity in the section. Medium- and high-severity spalls should be repaired immediately to prevent the incidence of FOD. If the pavement can be restored to serviceable condition, spalls should be carefully patched for long-term service. If the pavement is beyond repair, temporary patching should be considered to control FOD.

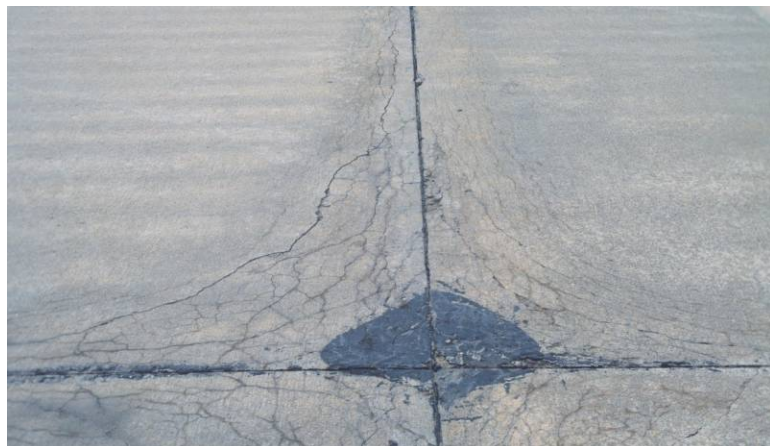
Example of Durability Cracking

Durability cracking (D-cracking) is caused by environmental factors, the most common of which is freezing/thawing. It usually appears as a pattern of hairline cracks running parallel to a joint or crack, or in a corner, where water tends to collect. This type of cracking eventually leads to disintegration of the pavement, creating FOD potential. At low severity, D-cracking is evident, but no disintegration has occurred. As the distress advances to medium severity, the distress pattern is evident over a significant area of the slab, and some disintegration and FOD potential exists. High severity durability cracking is evidenced by extensive cracking with loose and missing pieces and significant FOD potential.

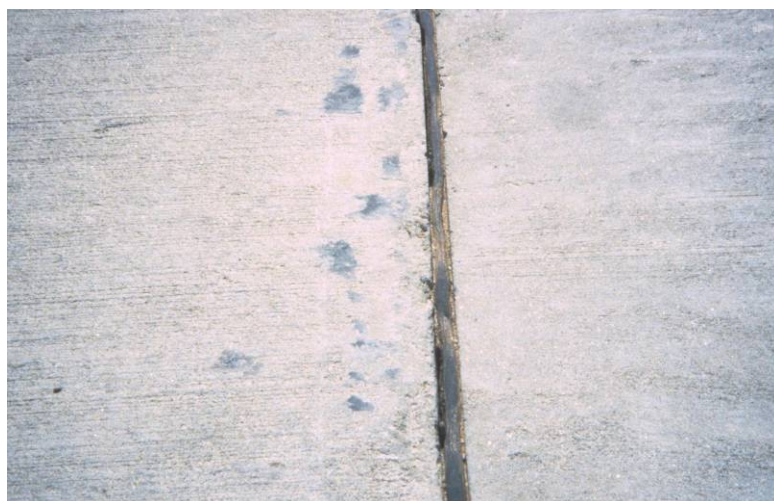
Example of Joint Seal Damage

Joint seal damage is recorded at three severities: low, medium, and high. When joint sealant is in perfect condition (no damage), it is not a distress. At low severity, at least 10 percent of the sealant is debonded but still in contact with the joint edges (i.e., joint sealant is in serviceable condition but should

be monitored for evidence of more serious failure). Medium-severity joint seal damage is recorded when at least 10 percent of the sealant has visible gaps smaller than 1/8th inch and is an indicator that replacement should be programmed as soon as is practicable. In the meantime, aggressive inspection and sustaining maintenance is recommended to minimize subsurface damage from moisture penetration. At high severity, visible gaps exceed 1/8th inch and the amount and degree of joint seal damage is such that repair is no longer feasible. The only appropriate corrective action is sealant replacement.

On serviceable pavement, deteriorated joint sealant should be repaired or replaced to preserve pavement and subgrade integrity and prolong service life. The issue is not so clear-cut with unserviceable pavement. Pavement that can be restored to serviceable condition by maintenance activities such as patching and joint seal repair, or by slab replacement, should be so maintained as long as the process is cost-effective. However, when age and condition preclude economical return to serviceable condition by such means, joint seal repair would no longer be cost-effective and should be suspended except for an interim maintenance program to control FOD potential.

Joint seal damage at medium and high severity should be repaired. If medium- and high-severity damage is limited to less than about 25 percent of total joint length, sustaining maintenance is recommended. If medium and high-severity damage exceeds about 25 percent of the total joint length, joint sealant should be removed and replaced under a restorative repair project.

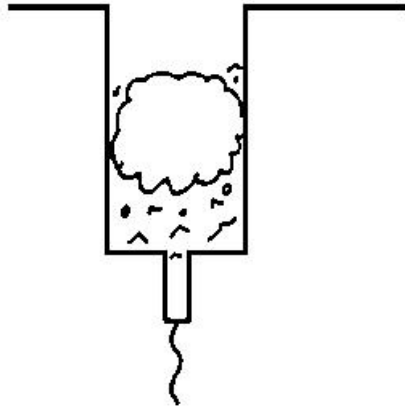
Typical joint with deficient sealant and a collection of debris & incompressibles.
